NONDESTRUCTIVE EVALUATION OF METAL FATIGUE

FINAL SCIENTIFIC REPORT

SwRI Project No. 15-4163

Air Force Office of Scientific Research

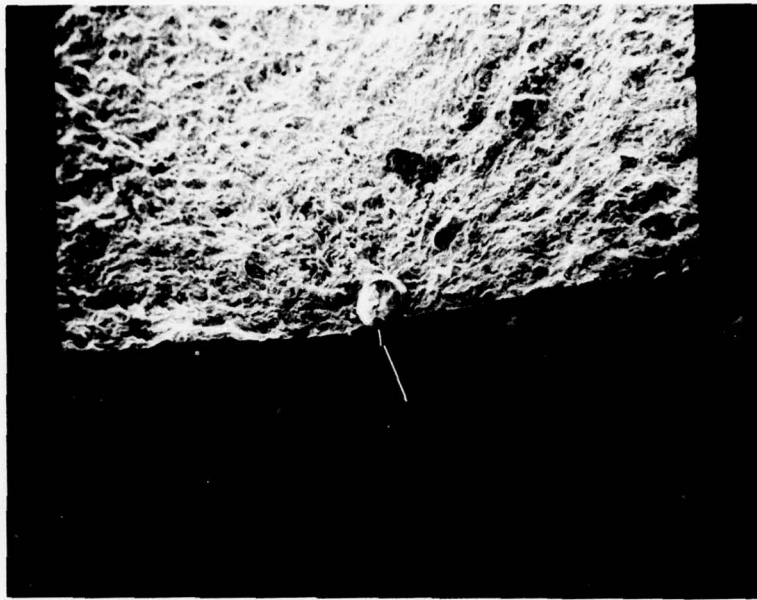
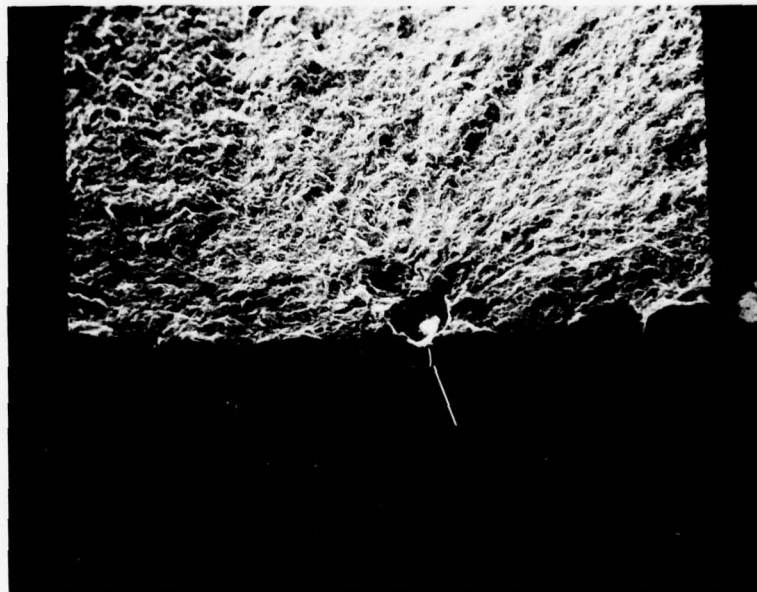
(a) Crack No. 1. Magnification 240X

(b) Crack No. 2. Magnification 240X

FIGURE 20. FATIGUE CRACK INITIATION SITES IN AISI 4340 STEEL (Specimen S5). Arrows indicate inclusions

nonmetallic inclusions. Although not investigated, their chemical makeup is probably duplex, that is, calcium aluminate and aluminum oxide.⁽²⁾ Both inclusions, which touched the surface, appear to have fractured during stress cycling, although closer examination indicates that debonding also took place.

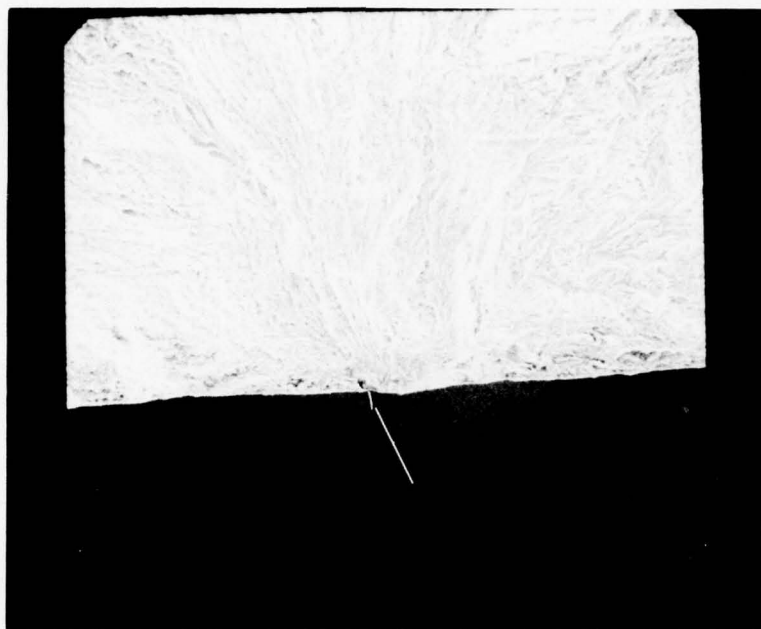
FIGURE 21. FATIGUE CRACK INITIATION SITE IN HY 180 STEEL
Specimen H1

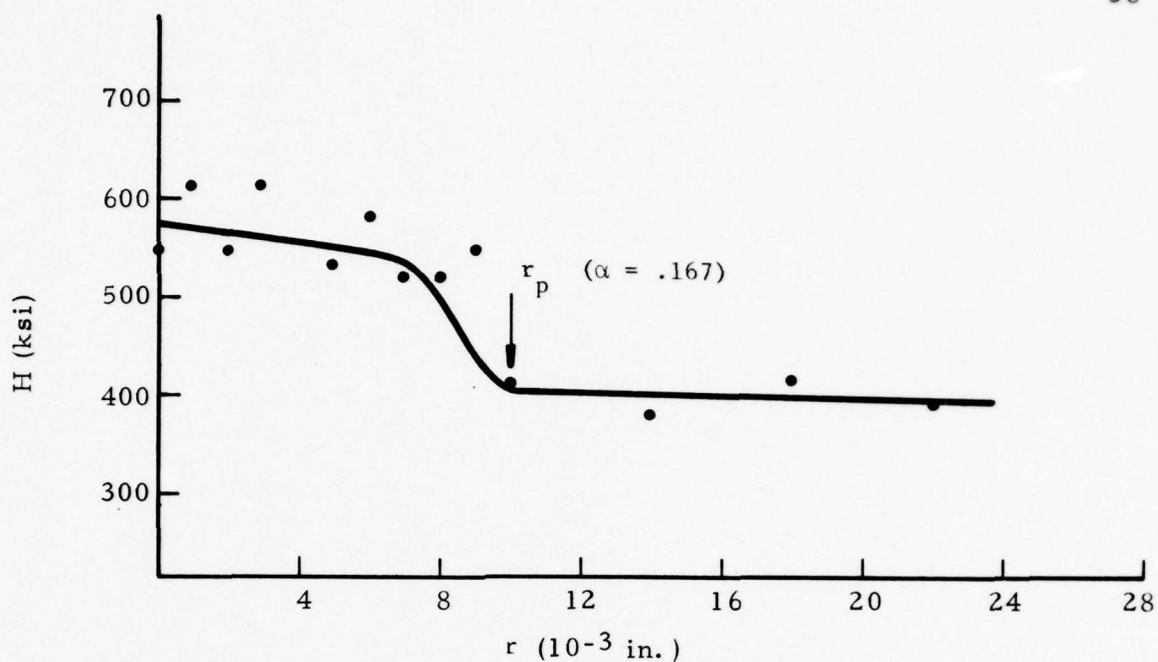
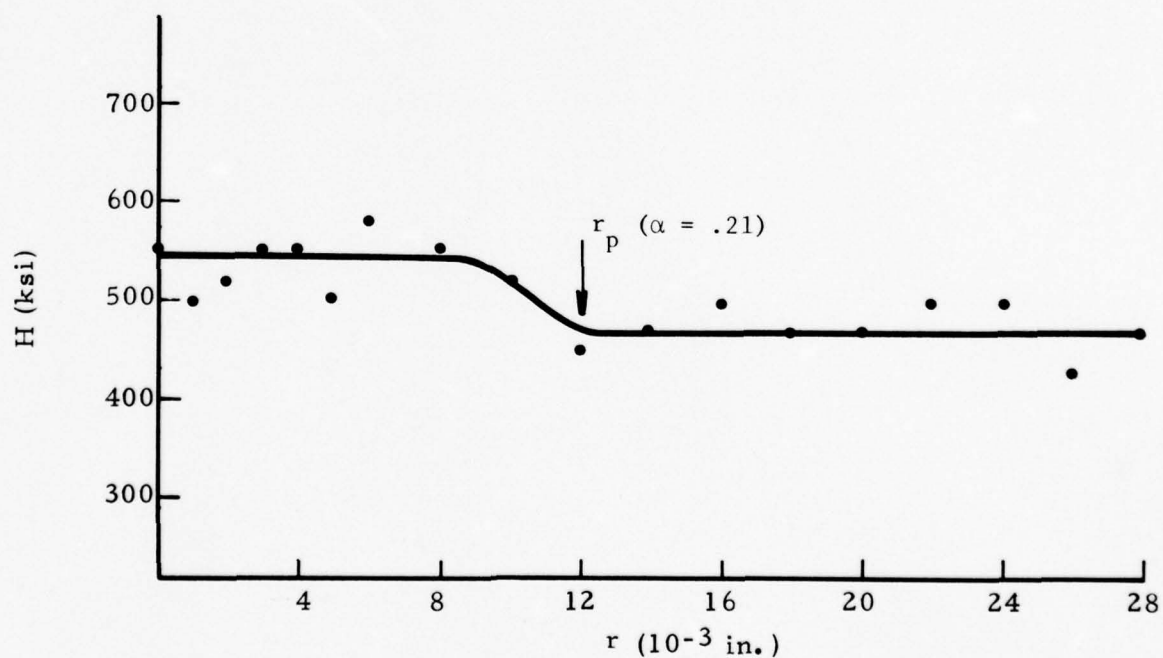
(a) Microhardness Profile Parallel to Crack Plane

(b) Microhardness Profile Perpendicular to Crack Plane

FIGURE 22. NEAR SURFACE (0.001-0.002-in.-deep) PLASTIC ZONES

Near the surface (Figure 22) the hardness readings indicate fatigue hardening in both directions relative to the crack plane. Parallel to the crack plane the apparent plastic zone boundary lies at about 0.010-in. while perpendicular to the crack plane the boundary is about 0.012-in. away. Slightly deeper within the specimen a shift in this trend is observed. As shown in Figure 23 hardness readings normal to the crack plane from two directions show in one case no change at all (Figure 23a) and in another case a slight softening (Figure 23b); in the latter instance, the boundary lies at about 0.010-in. Readings obtained parallel to the plane of the crack for this

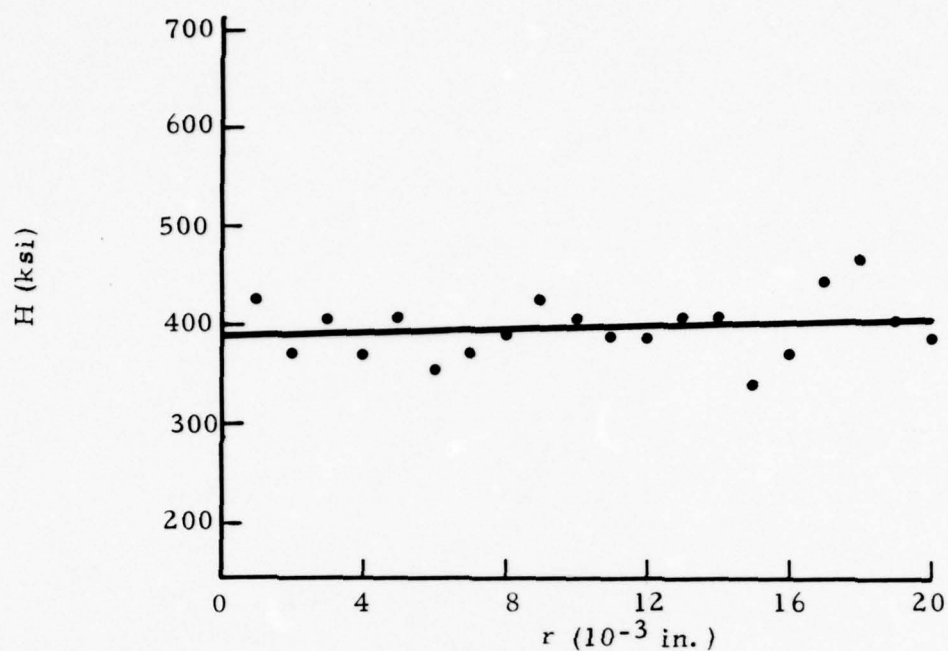
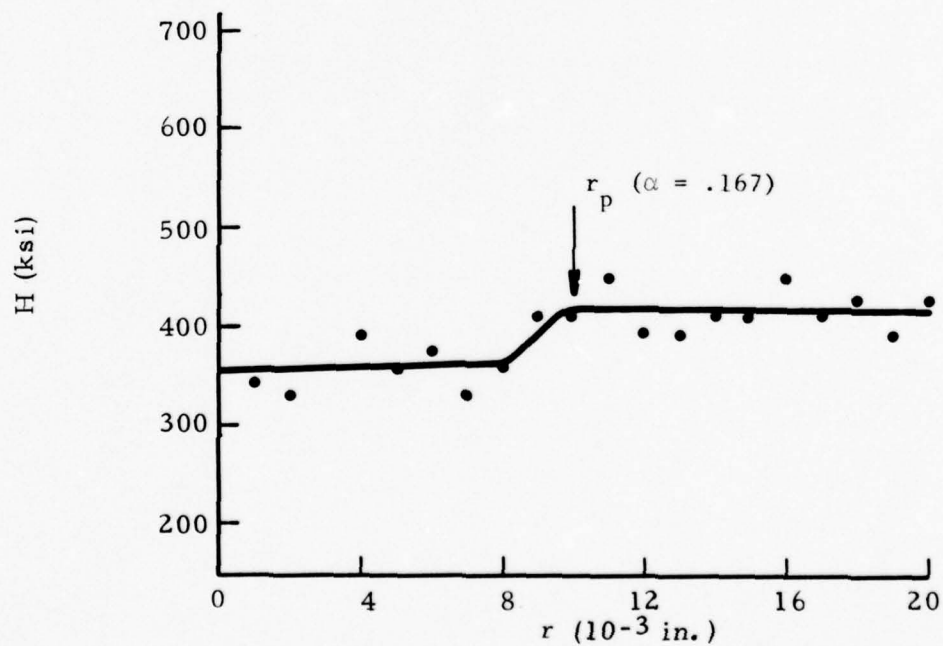
FIGURE 23. PLASTIC ZONES AT 0.002-0.003-IN. DEPTH

To obtain best characterization of fatigue cracks, it is important to know the distance over which it might be expected that the NDE inspection probes would be affected by the plastic zones at the fatigue crack tips. Accordingly, the approximate crack-tip plastic zone dimensions were determined in an AISI 4340 steel specimen using the microhardness approach. This technique recently has been applied with apparent success to both maraging steels and to austenitic stainless steels.⁽¹⁰⁾ Because of the high strength of the former steels (which are similar to both AISI 4340 and HY 180 steels), the fatigue process induces cyclic softening within the plastic zone. Softening is, therefore, what might be expected in the AISI 4340 and HY 180 steel specimens. The specimen selected for this study was cycled at 130 ksi and contained a 0.050-in.-long crack such that the average stress intensity factor along the crack tip had been approximately $43 \text{ ksi}\sqrt{\text{in.}}$. The microhardness profiles, obtained at depths of 0.001-in. to 0.002-in., 0.002-in. to 0.003-in., and approximately 0.010-in., are summarized in Figures 22, 23, and 24.

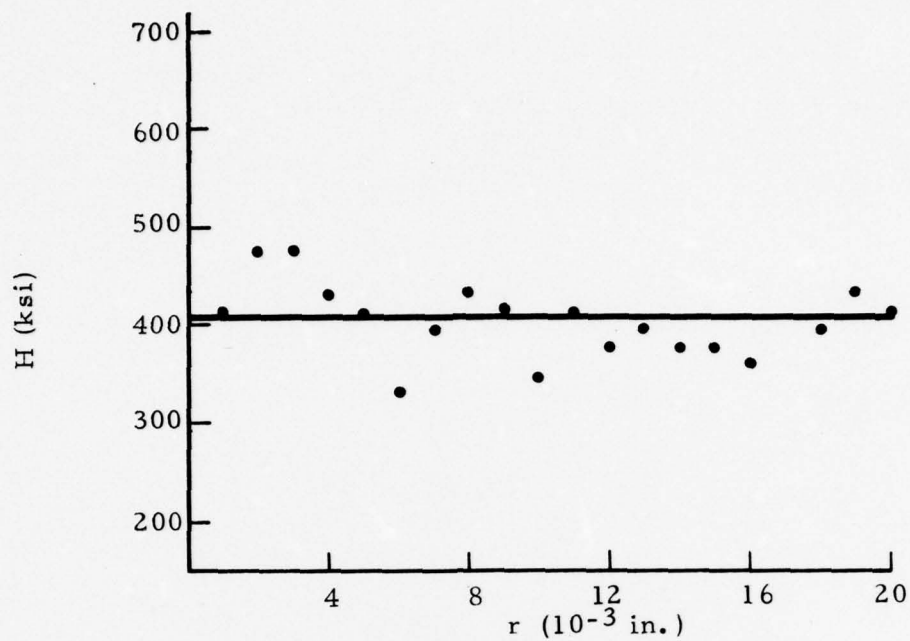
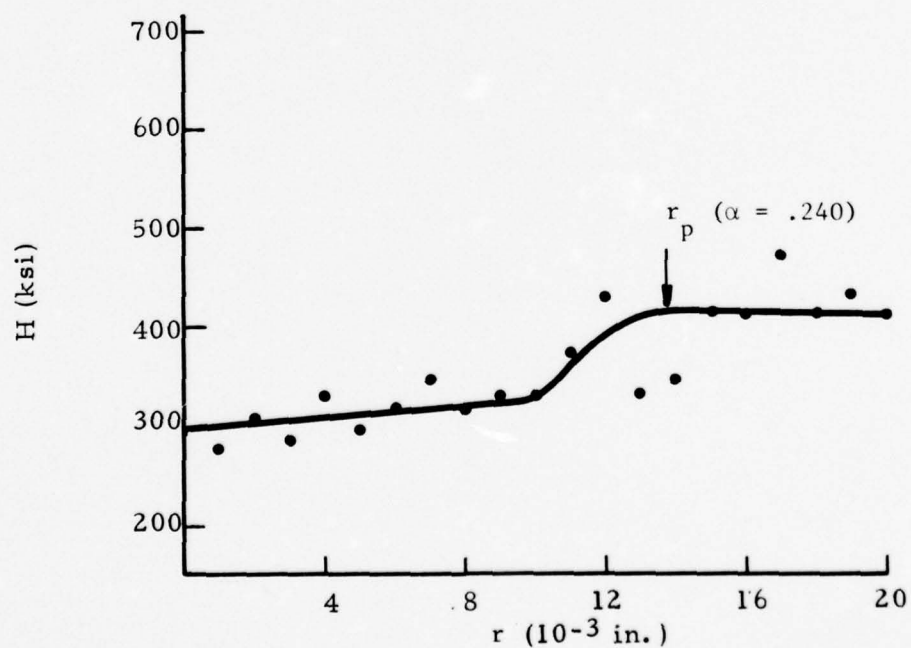
FIGURE 24. INTERIOR (0.010-in. -deep) PLASTIC ZONES

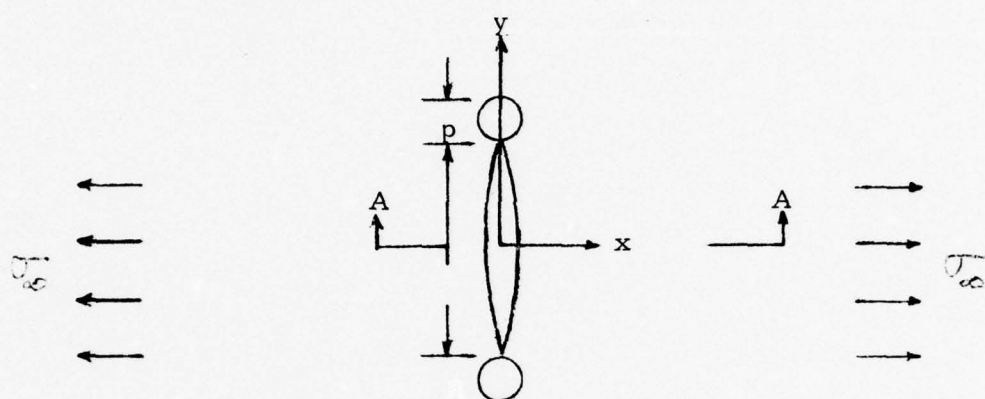
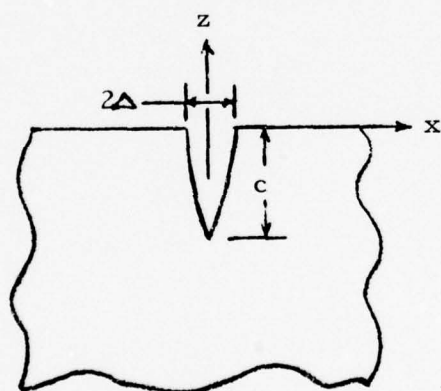
ν is Poisson's ratio and E is Young's modulus. The shape of the flaw on the surface may be described approximately by two parabolic curves intersecting at the crack tips ($y=\pm c$) and separated by a distance 2Δ , the crack opening displacement at $y=0$. If the crack opening at any distance y along the crack is designated by 2δ then

FIGURE 25. SURFACE FLAW GEOMETRY

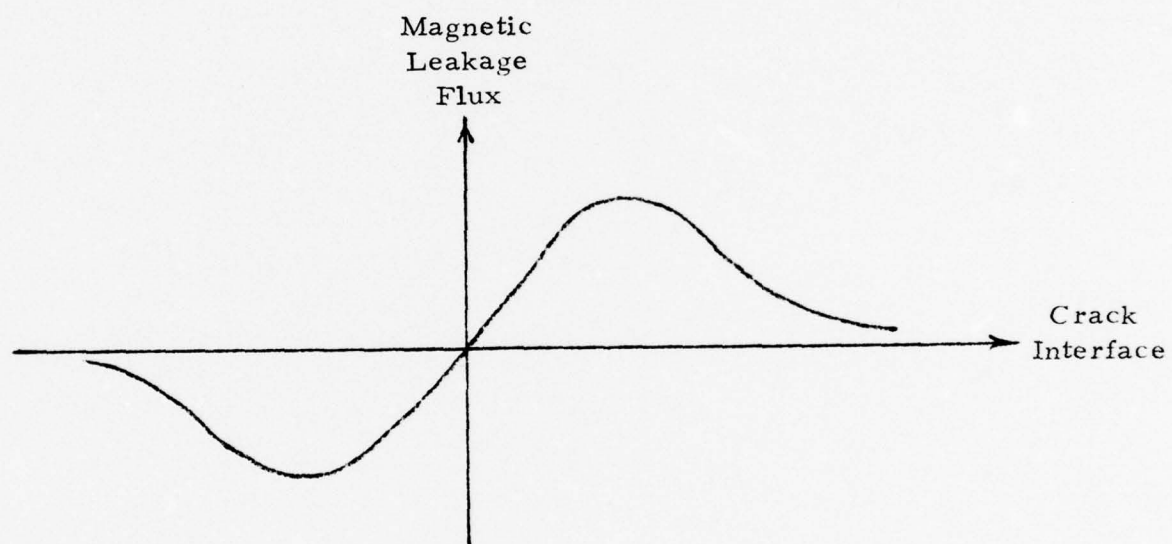
FIGURE 26. CALCULATED MAGNETIC LEAKAGE FLUX VERSUS
DISTANCE ALONG CRACK INTERFACE

In an attempt to bring the analytical model into better conformance with experimental results, it was modified by including a "process zone" so that a half-penny shaped crack of length $2(c+p)$ is considered where p is the linear dimension of the process zone (see Figure 25). For purposes of computation, the quantity p is taken to be the plastic zone size estimated

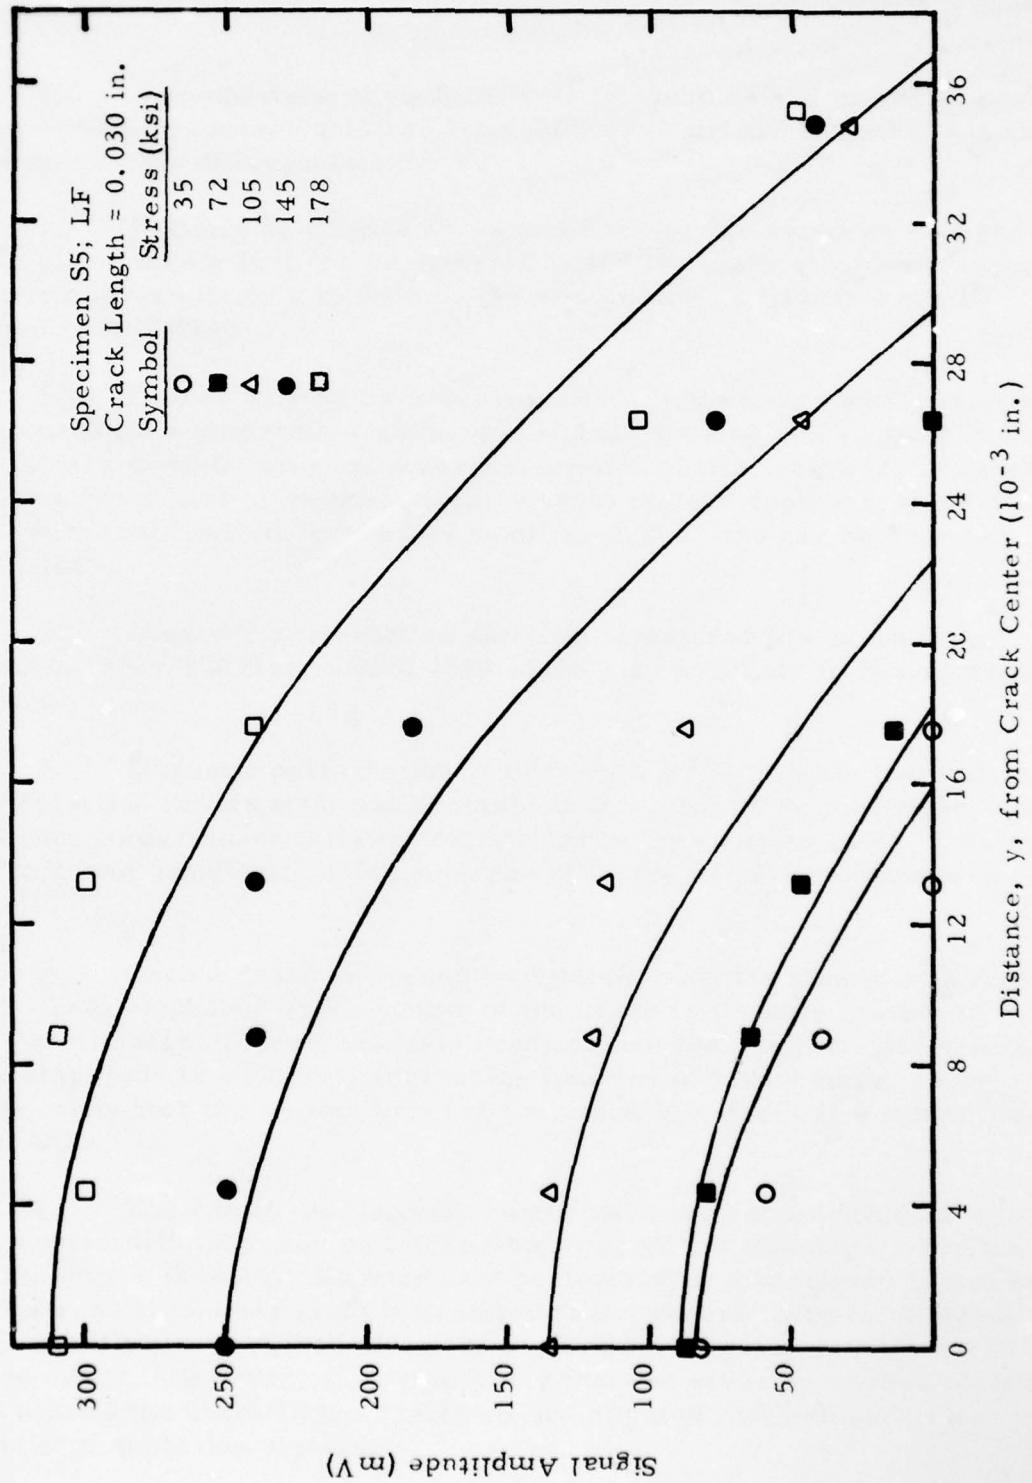
FIGURE 27. EXPERIMENTAL AND CALCULATED MAGNETIC PERTURBATION SIGNAL AMPLITUDE VERSUS LOCATION ALONG CRACK INTERFACE FOR VARIOUS STRESS LEVELS

Some of the results obtained with the model are shown in Figure 27 compared with experimental data. These results are for a 0.03-in.-long crack in AISI 4340 steel Specimen S5. Plotted in Figure 27 is the magnetic perturbation signal amplitude versus location along the crack interface for several different static stress levels. In each case the computed curve was fitted to the experimental data at $y=0$. As can be seen, the agreement between the model predictions and the experimental data is reasonably good and the inclusion of a process zone correction into the model helps to account for the signal amplitude observed beyond the crack tip. Although the results shown here are for a 0.03-in. crack in an AISI 4340 steel specimen, similar results were found for other cases considered, including those in HY 180 steel.

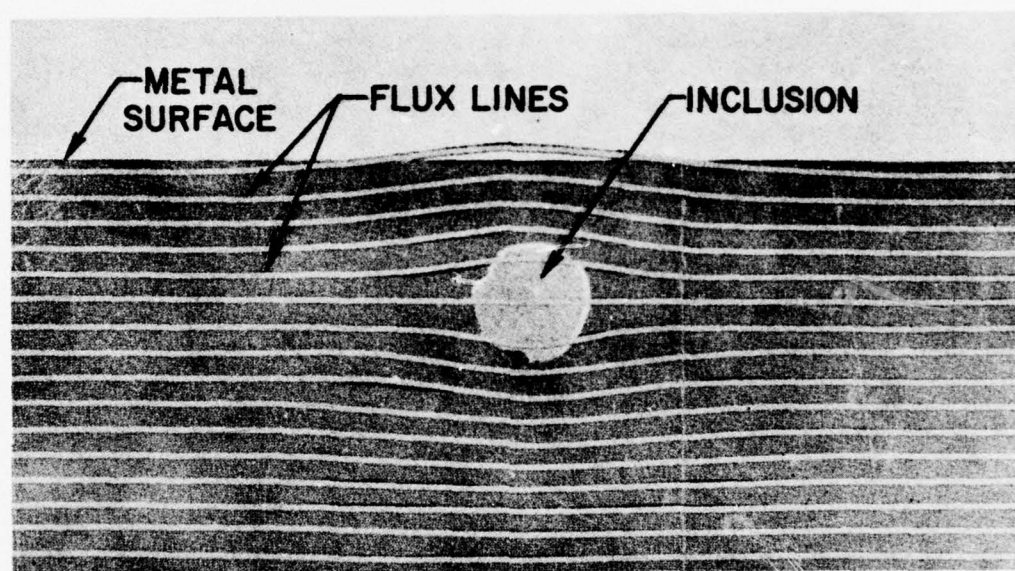
FIGURE B-1. PERTURBATIONS IN MAGNETIC FLUX CAUSED BY INCLUSION IN FERROMAGNETIC MATERIAL

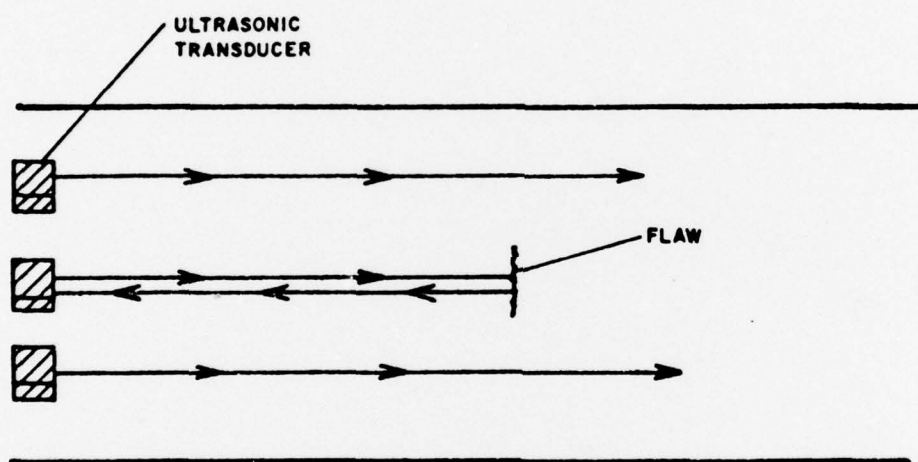
FIGURE B-2 ULTRASONIC SURFACE WAVE PULSE-ECHO METHOD. Influence of a Flaw on Propagation of Acoustic Energy.

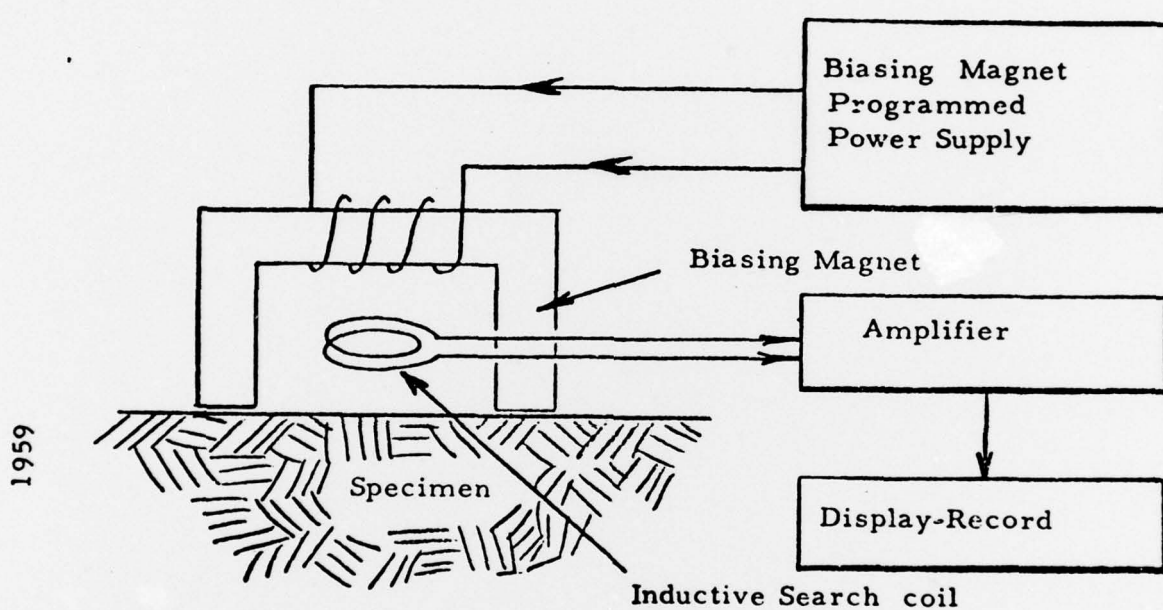
FIGURE B-3 SCHEMATIC DIAGRAM OF THE ESSENTIAL FEATURES OF AN ARRANGEMENT FOR INDUCTIVELY SENSING THE BARKHAUSEN EFFECT

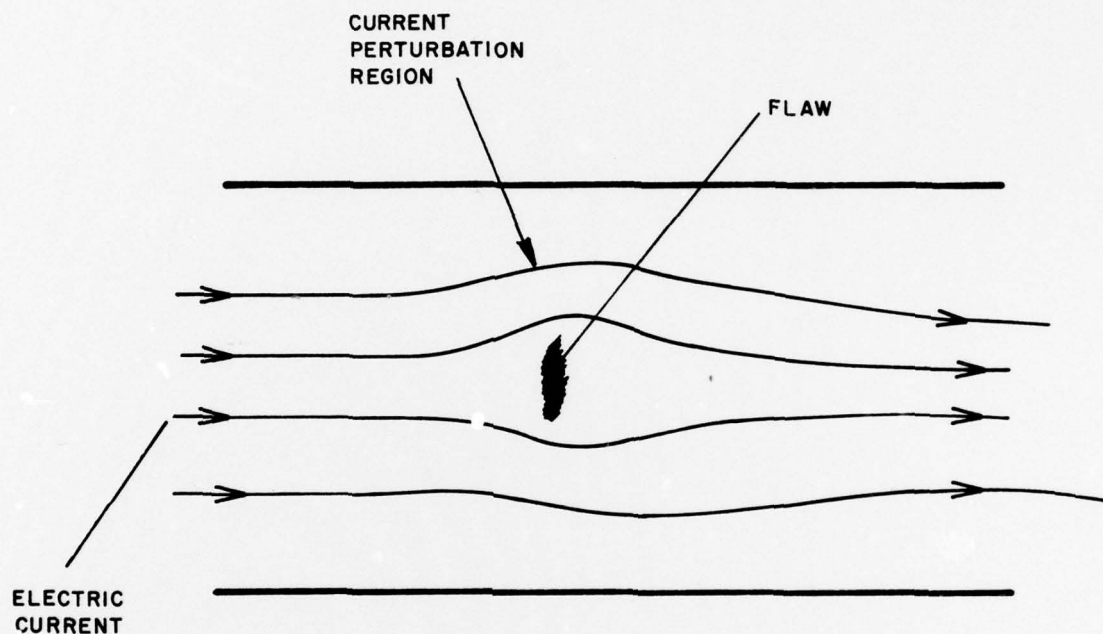
FIGURE B-4. ELECTRIC CURRENT INJECTION METHOD
Influence of a Flaw on Electric Current
Distribution

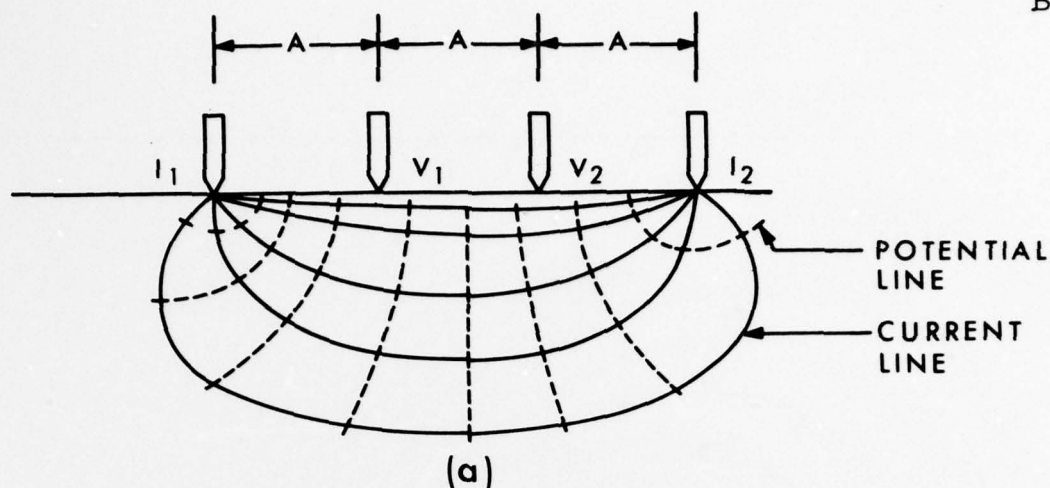
FIGURE B-5. OPERATION OF AC FOUR CONTACT ELECTRIC PROBE
 (a) ON UNCRACKED AND (b) ON CRACKED MATERIAL. The current contacts I_1 and I_2 are driven by a current generator. The signal from the voltage contacts V_1 and V_2 is amplified and synchronously detected.

The AC four-contact electric probe method is an electrical potential approach whereby two outer electrical contacts inject current and two inner contacts sense the electric potential, as shown schematically in Figure B-5a. The presence of a crack between the inner contacts causes a disruption of the electric potential due to the insulating barrier formed by the crack, as shown in Figure B-5b. By comparing the voltages measured at constant current on cracked and uncracked specimens, in principle, electric potential theory can be used to precisely calculate the crack depth. In practice, however, it has been found more convenient to calibrate the probe using a reference flaw, i. e., a machined slot which simulates the anticipated crack size, shape and location. The AC approach circumvents the difficulties associated with the generation of thermal emf's. encountered in the conventional DC approach. Adequate penetration depth is obtained with the AC method by using low frequency (100 Hz), and synchronous detection is used to discriminate against incoherent noise, resulting in much greater sensitivity than can be obtained with the DC technique. This greater sensitivity permits the use of very small drive currents, on the order of 16 ma.

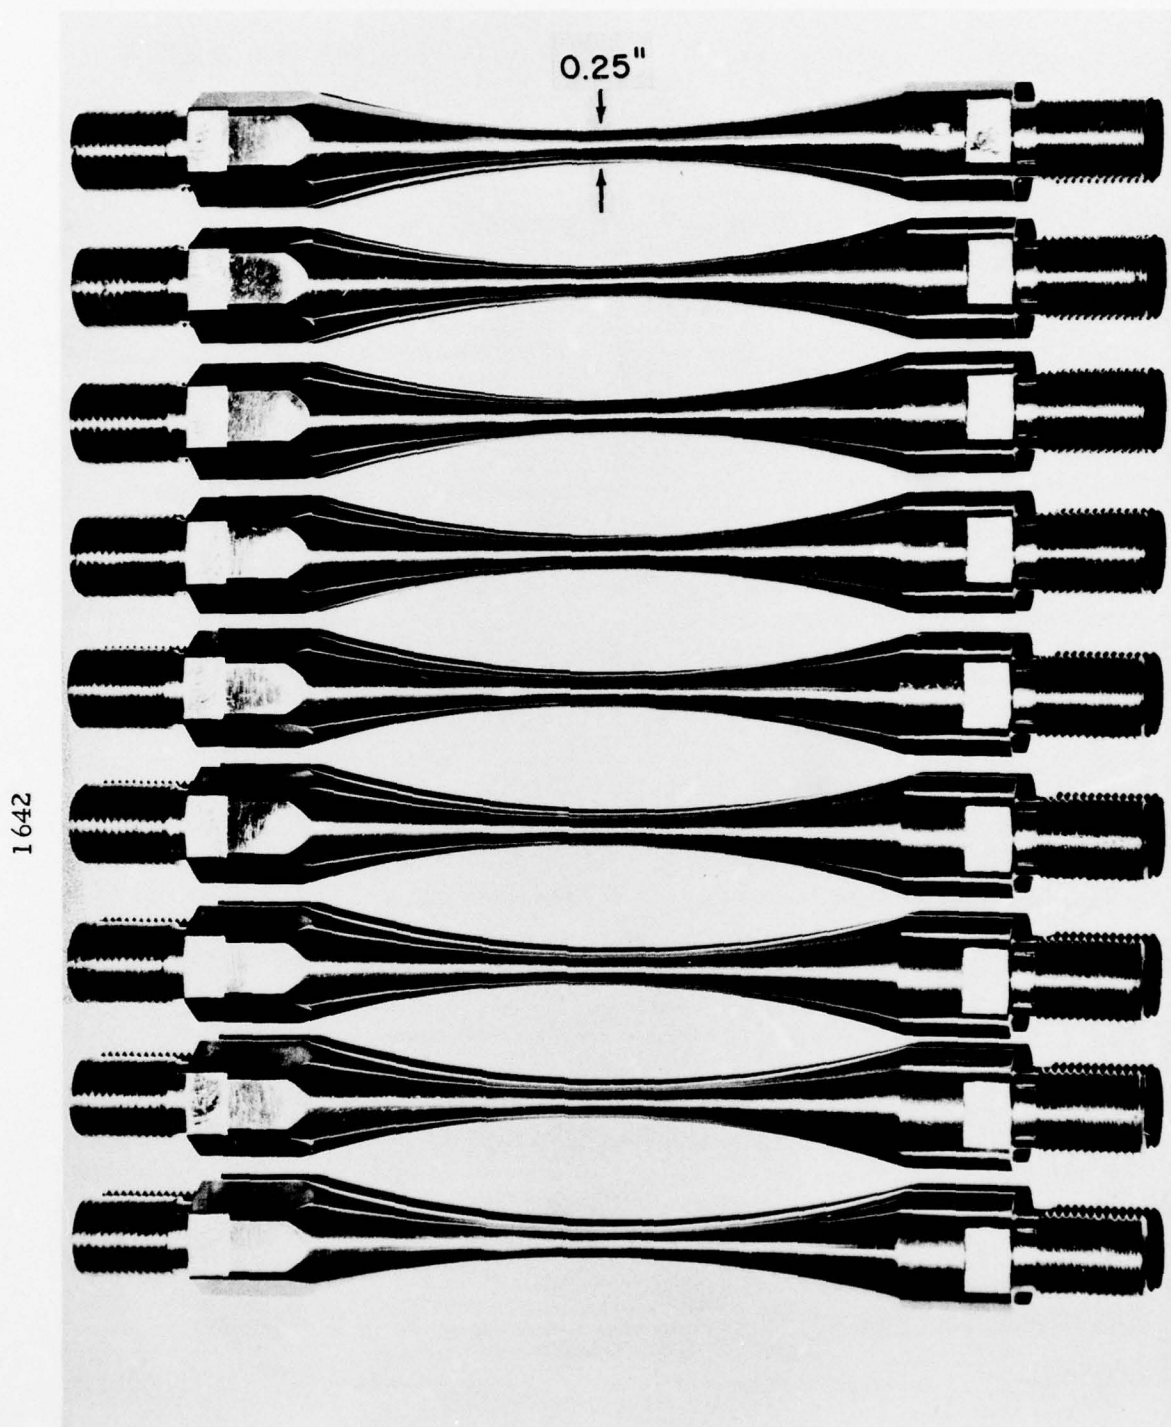
FIGURE C-1. PHOTOGRAPH SHOWING SEVERAL TYPICAL AISI 4340 STEEL TEST SPECIMENS

The specimens used in the experiments were polished, rod-type specimens of AISI 4340 steel and HY 180 steel. Six flats were machined near one end of the specimens for bonding of the ultrasonic transducers. After heat treatment, machining, and polishing, measurements showed the AISI 4340 and the HY 180 steel specimens to have an average 0.2% offset tensile yield strength of 183 ksi and 183.6 ksi, respectively. Details of the specimen preparation, heat treatment schedule, and the average mechanical properties are given in Appendix C.
